# FAILURE MECHANISMS IN AIRCREW HELMET VISORS

September 1996

Final Technical Report for the Period 1 September 1993 to 29 March 1995

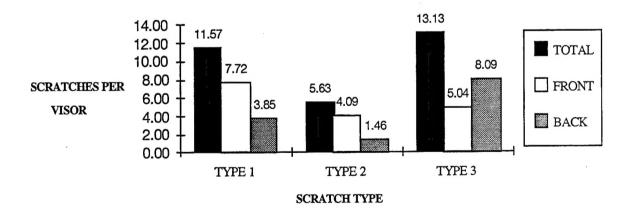
### AVERAGE NUMBER OF SCRATCHES PER VISOR

Table 1: Average Number of Scratches per Visor per Type of Scratch by Location

Type 1 scratch	11.57 total	7.72 front	3.85 back
Type 2 scratch	5.63 total	4.09 front	1.46 back
Type 3 scratch	13.13 total	5.04 front	8.09 back

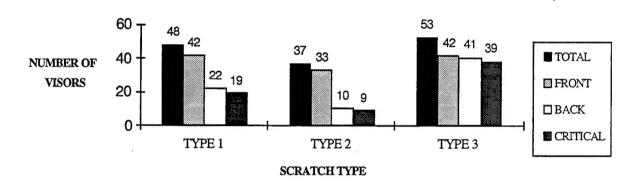
# NUMBER OF VISORS vs TYPE OF SCRATCH 53 VISORS MEASURED

Table 2: Number of Visors Evidencing Each Type of Scratch by Location

Type 1 scratch	48 total	42 front	22 back	19 critical area
Type 2 scratch	37 total	33 front	10 back	9 critical area
Type 3 scratch	53 total	42 front	41 back	39 critical area
